**RE: REVIEW OF OLIN SECOND QUARTER 2006 GROUNDWATER
MONITORING REPORT**

On behalf of the City of Morgan Hill (City), WorleyParsons Komex has reviewed the report by Olin Corporation (Olin) titled "Second Quarter 2006 Groundwater Monitoring Report, Olin/Standard Fusee Site, 425 Tennant Avenue, Morgan Hill, California" (the Report). Our review focused on the components of the report related to the northeast flow situation wherein perchlorate from the Olin/Standard Fusee site (the Site) has impacted the municipal water supply of the City of Morgan Hill (the City). Our review does not reference the various other potential perchlorate sources which at this time have not been shown to either exist, nor to impact groundwater (in particular the Deep Aquifer), nor to impact any well operated by the City. In particular we reviewed in detail Appendix E, Northeast Groundwater Flow Assessment – Update (Appendix E). The main findings of our review are discussed below. For reader convenience, cited figures from the Report are enclosed with this document.

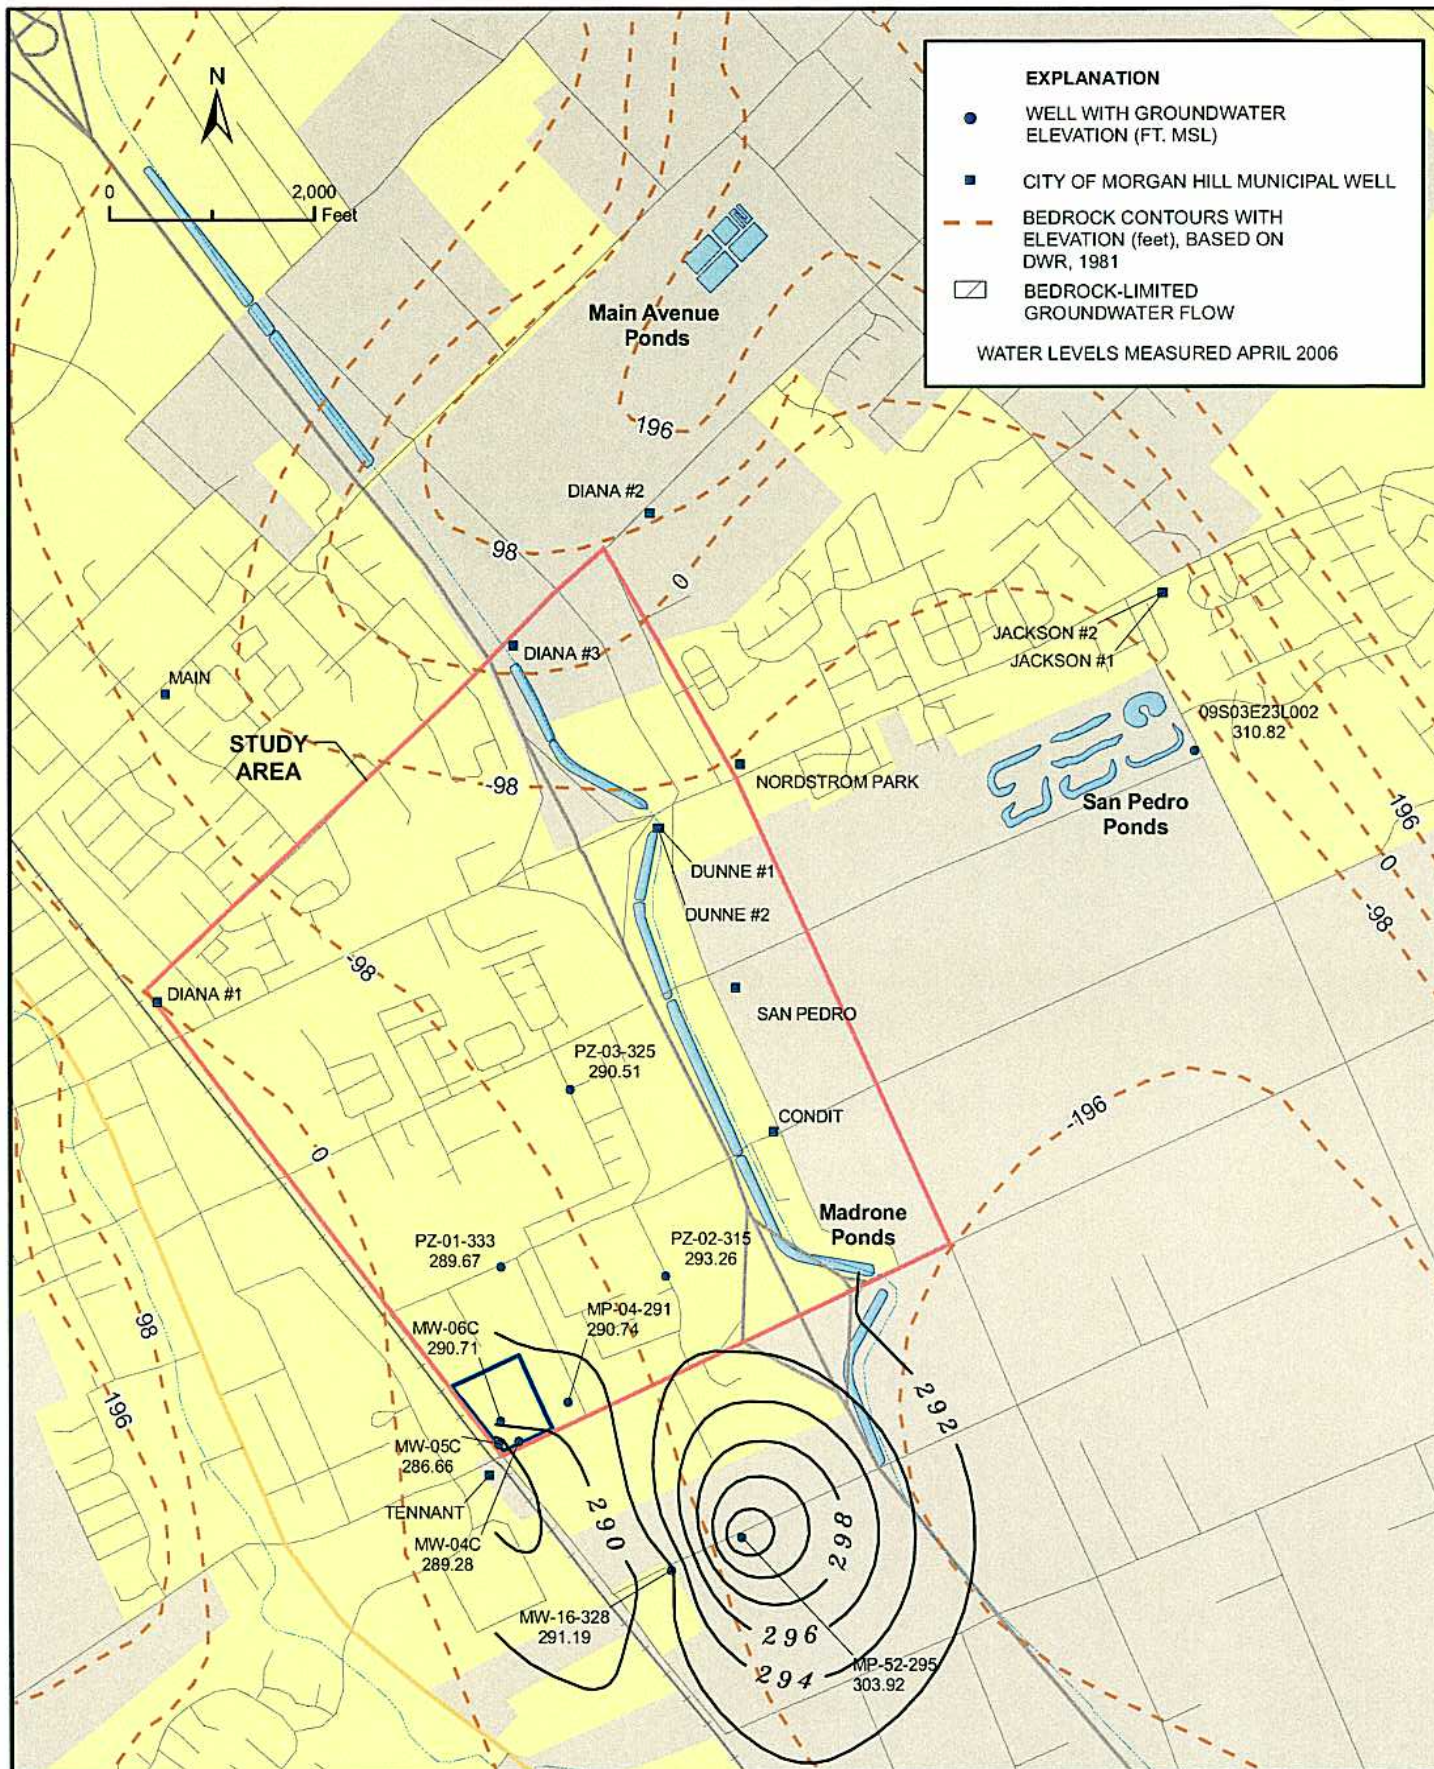
E5b

Groundwater Elevations - Deep Zone (Middle)

Second Quarter 2006 Groundwater Monitoring Report
Olin/Standard Fusee Site
Morgan Hill, California

Notwithstanding the lack of any perchlorate data from these wells, the water level data measurements taken by Olin again, for another consecutive quarter (now at least four consecutive quarters, from third quarter 2005) indicate groundwater flow to the north and northeast in the vicinity of the Site. Given this, the increasing numbers of wells northeast of the Site with perchlorate detections above 4 µg/L, the rising perchlorate concentrations in the northeast monitoring wells, and the recent discovery of J-Flag detections of perchlorate throughout the City's northeast wells, a substantial amount of data exist to confirm the northeast migration of perchlorate in groundwater originating from the Olin Site.

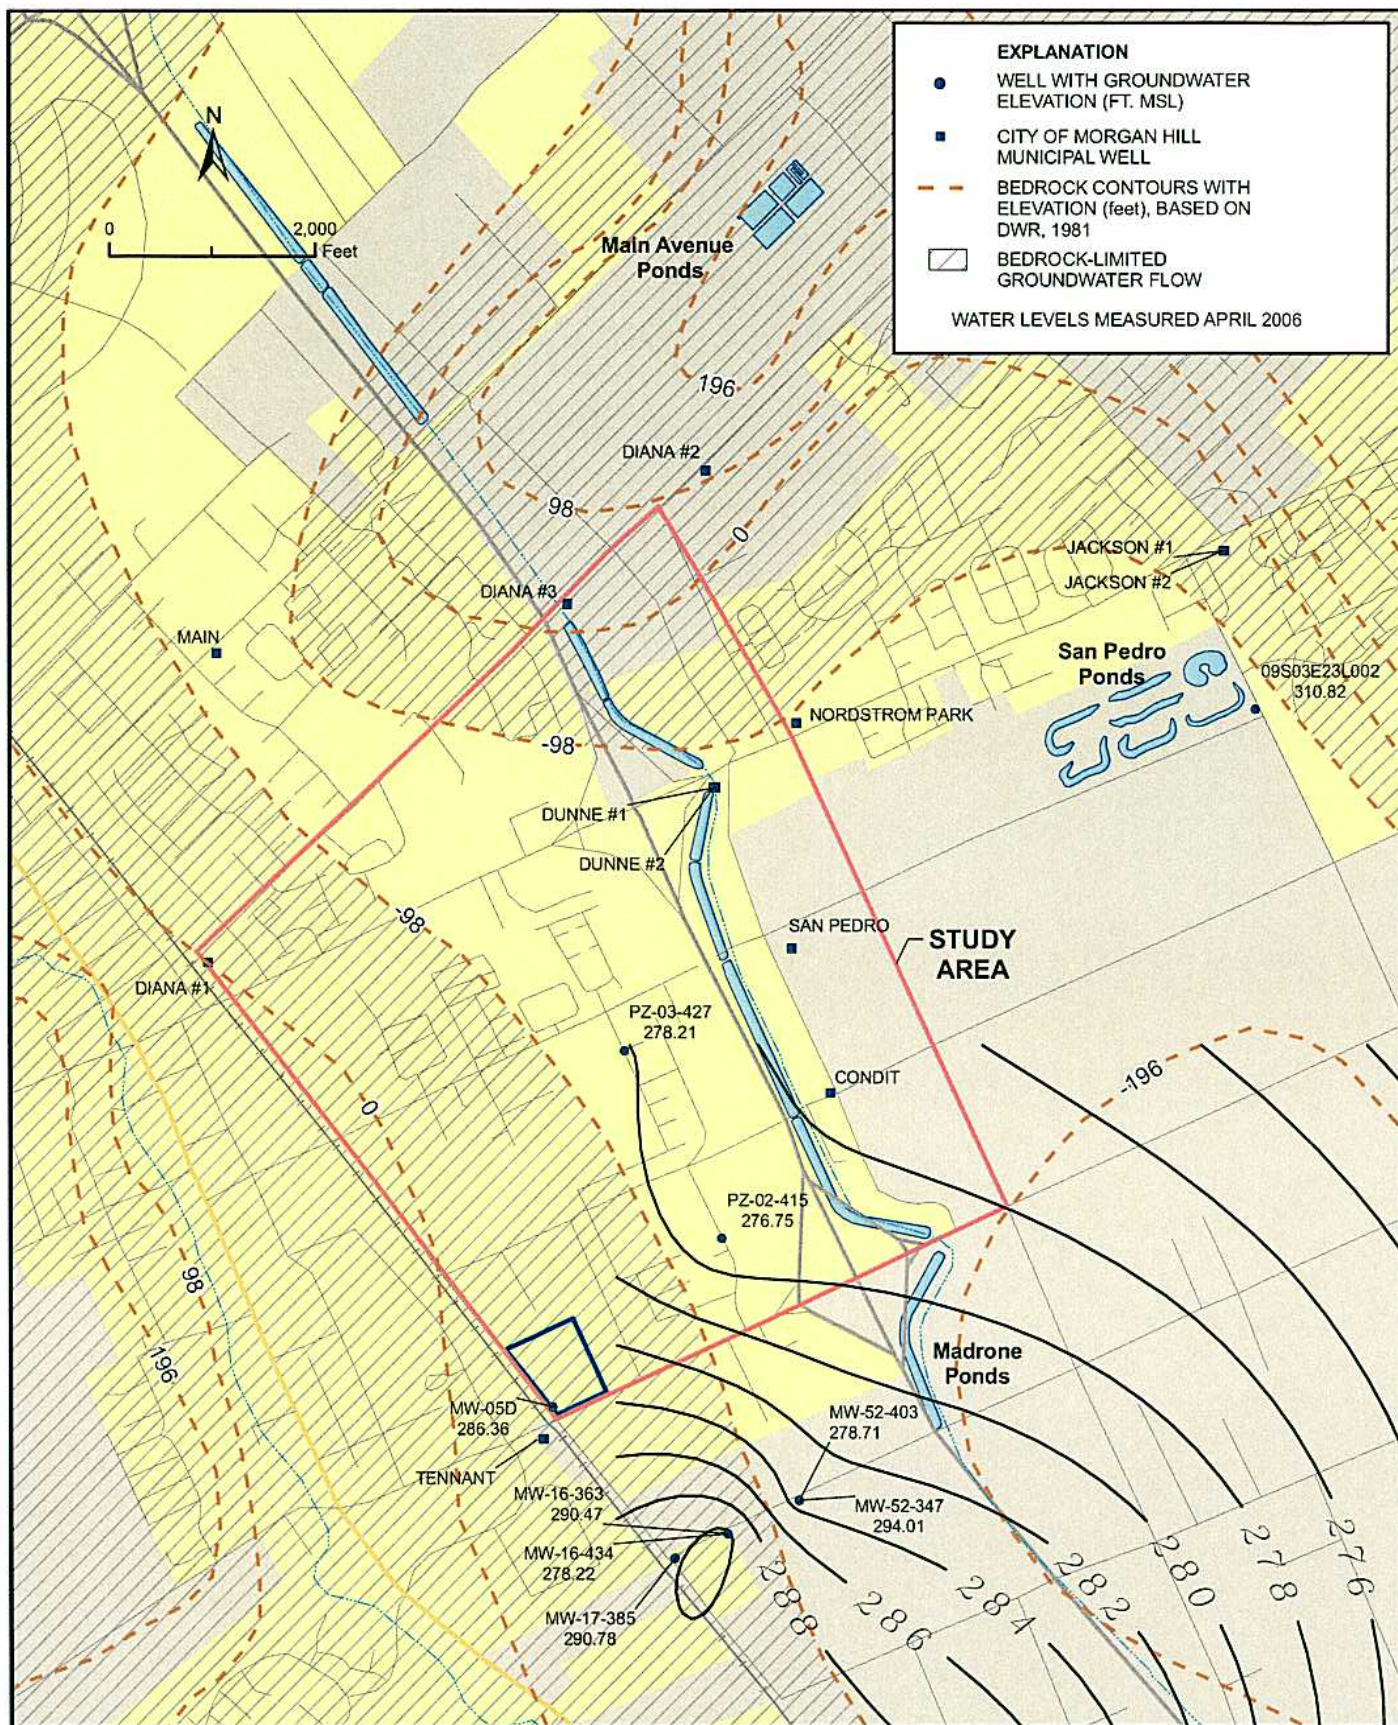
E5c

Groundwater Elevations - Deep Zone (Lower)
 Second Quarter 2006 Groundwater Monitoring Report
 Olin/Standard Fusee Site
 Morgan Hill, California

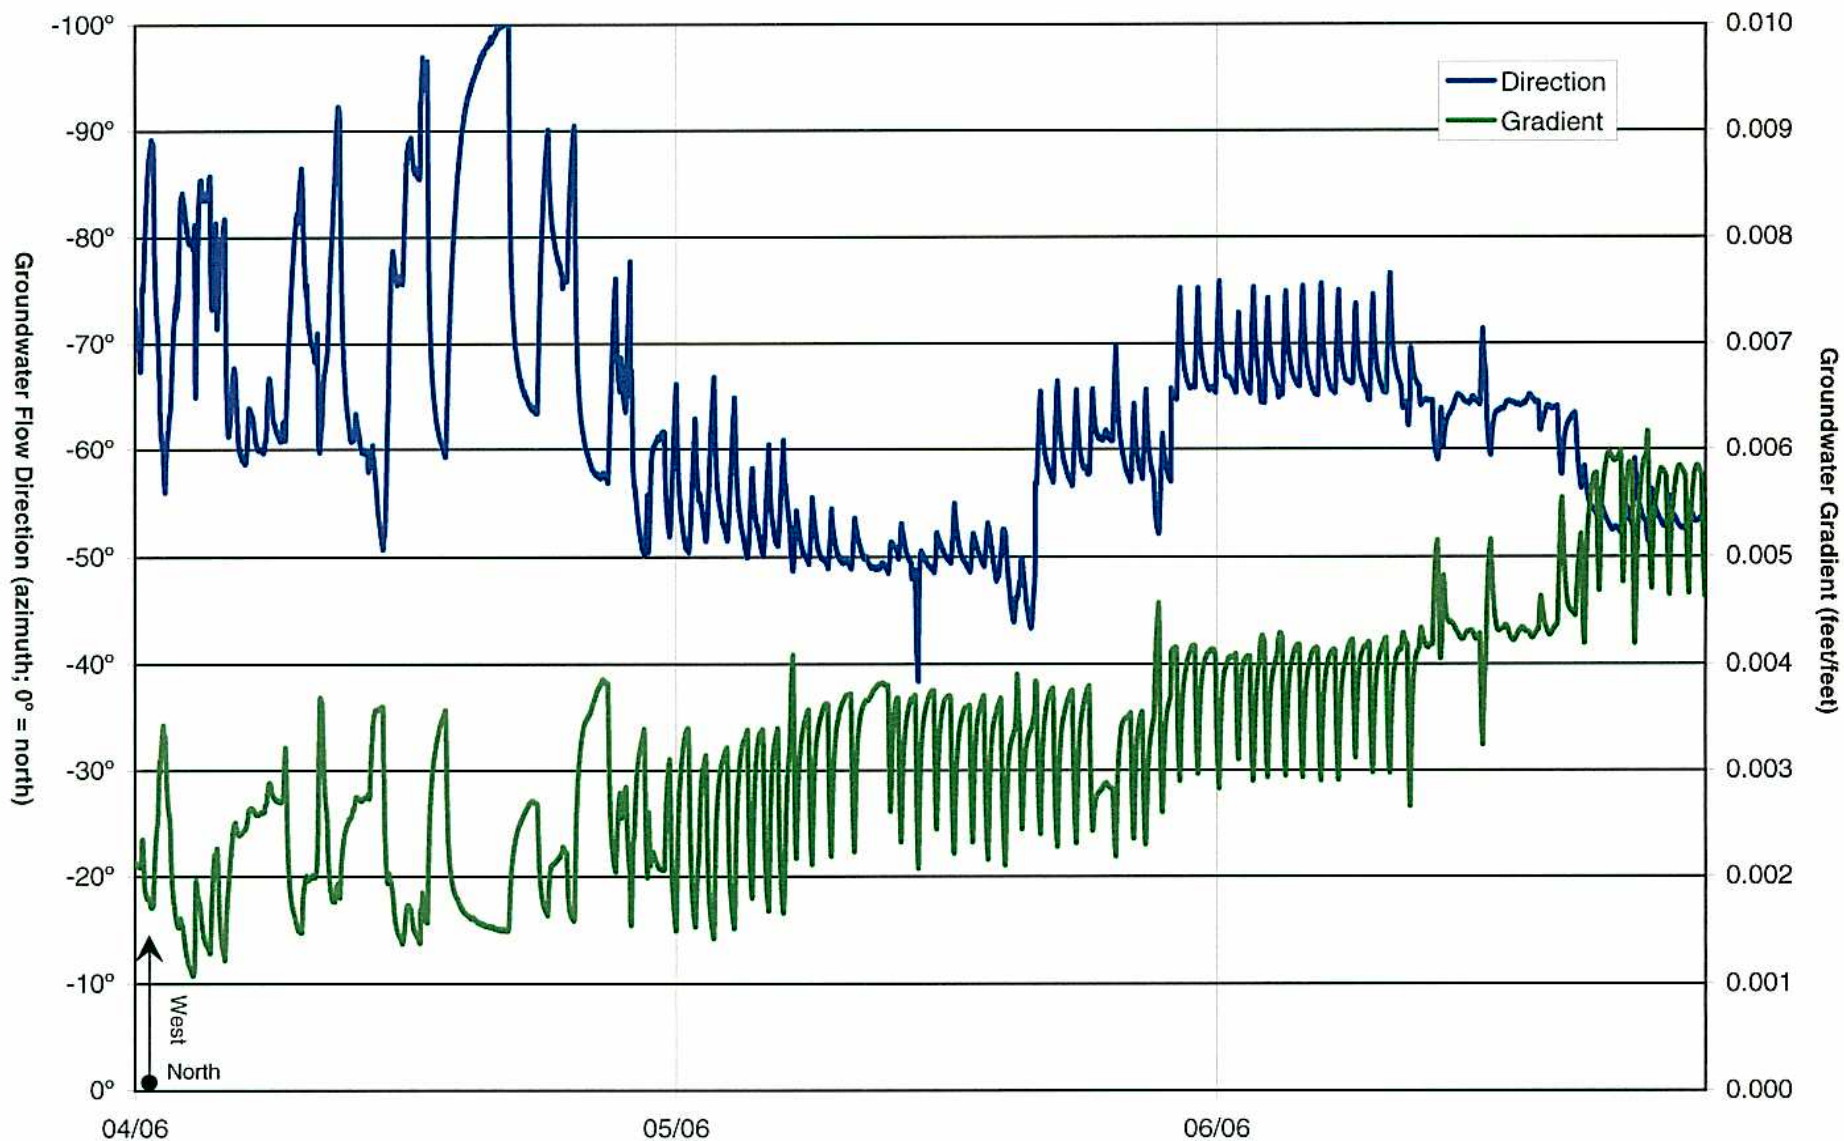
E13

**Groundwater Flow Directions and Gradients - Middle-Deep Aquifer
Second Quarter 2006 Groundwater Monitoring Report**

**Olin/Standard Fusee Site
Morgan Hill, California**

- 3) The text in the Report attempts to minimize the fact that there are north and northeastward gradients and makes statements directly in contradiction to the interpretation of water level elevations and resultant groundwater flow directions indicated in the figures cited in Comment #2 above. Although groundwater flow beneath, and in the immediate Site-vicinity in the Deep Aquifer is shown to be to the north and northeast as noted in Comment #2, the text of the Report in incorrectly states:
